175 MM M113 Cannon: Historical Perspective on the Cannon that changed our Cannon Design Process

NDIA Joint Armaments Symposium
14-17 May 2012

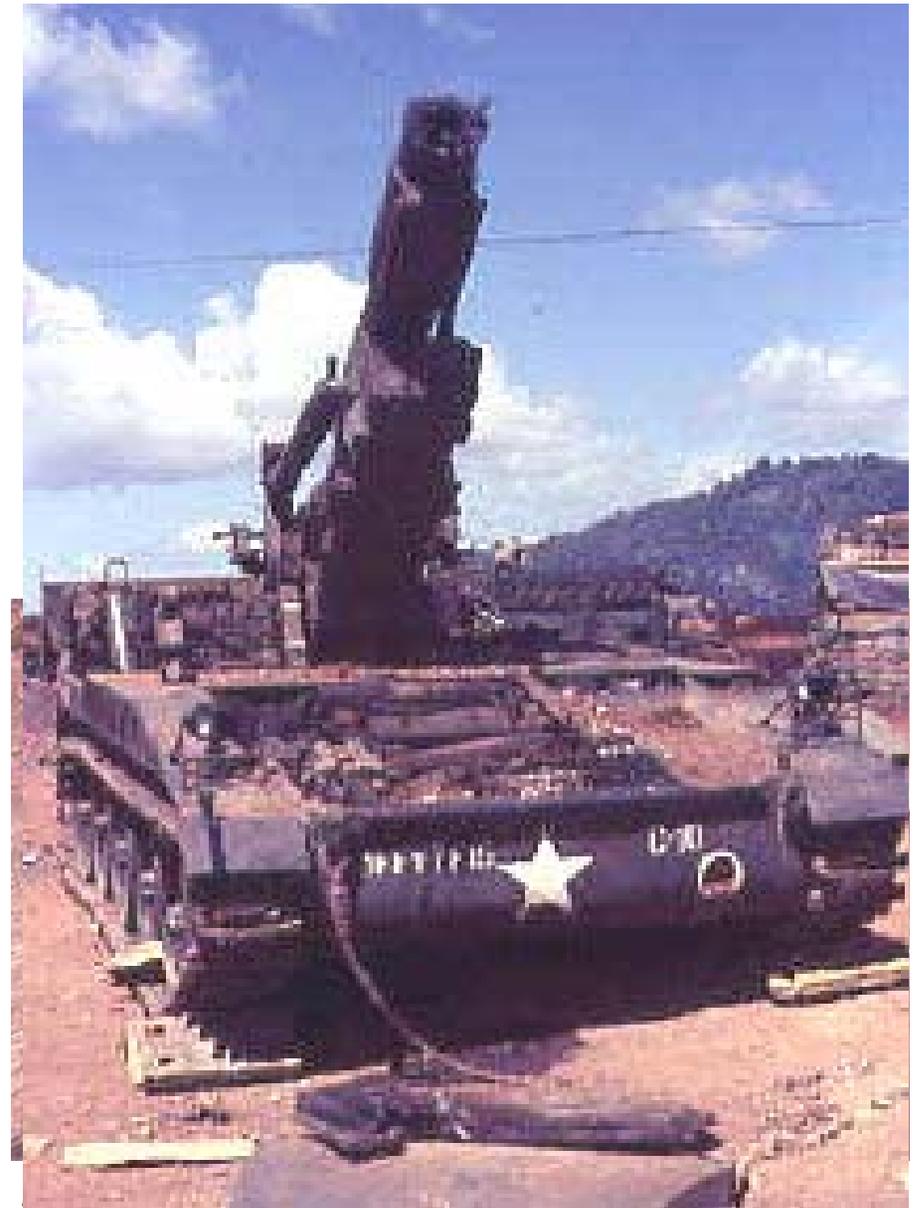
Testing of M1 Wear Additive showing drastic improvement in wear life (6)

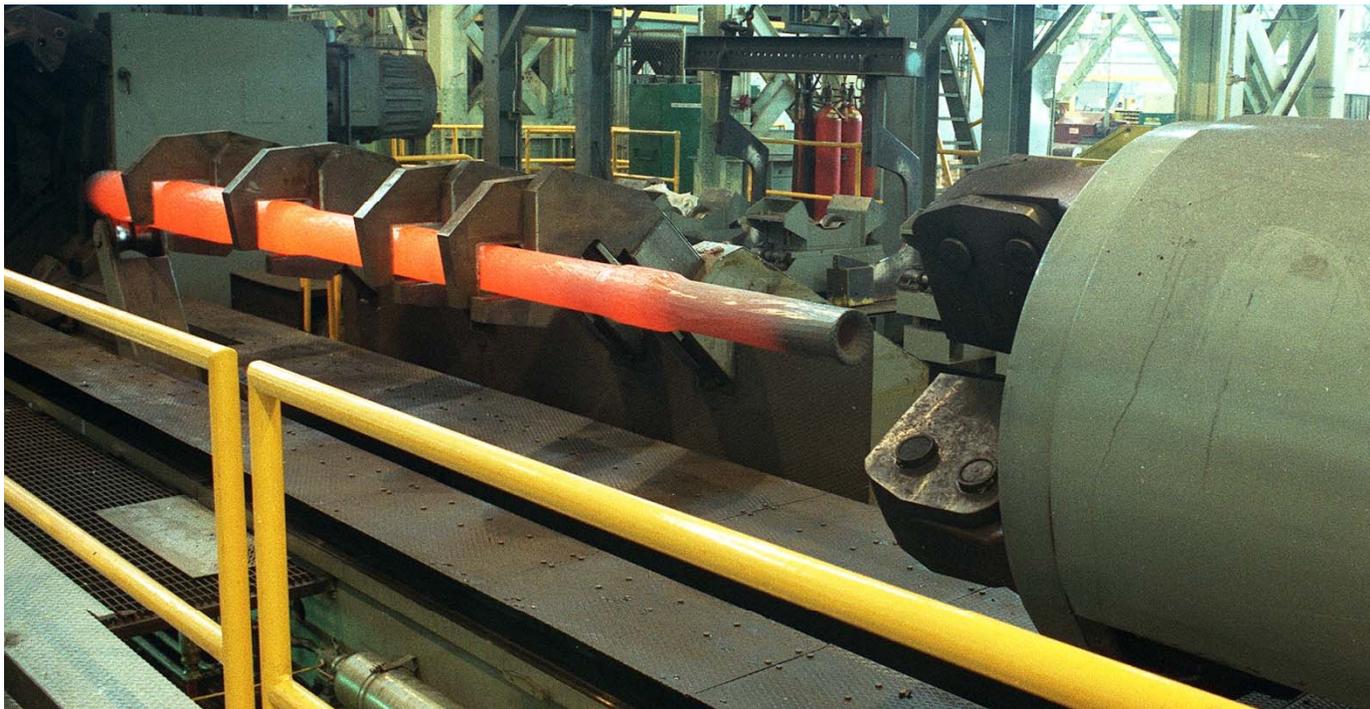
- In 1982, the Watervliet Arsenal embarked on the 'REARM' program - as part of this program,
 - Tube autofrettage techniques and design were significantly refined
 - a rotary forge was developed and installed at Watervliet to ensure tighter quality control . Included was extensive equipment to take samples from each tube produced for examination.

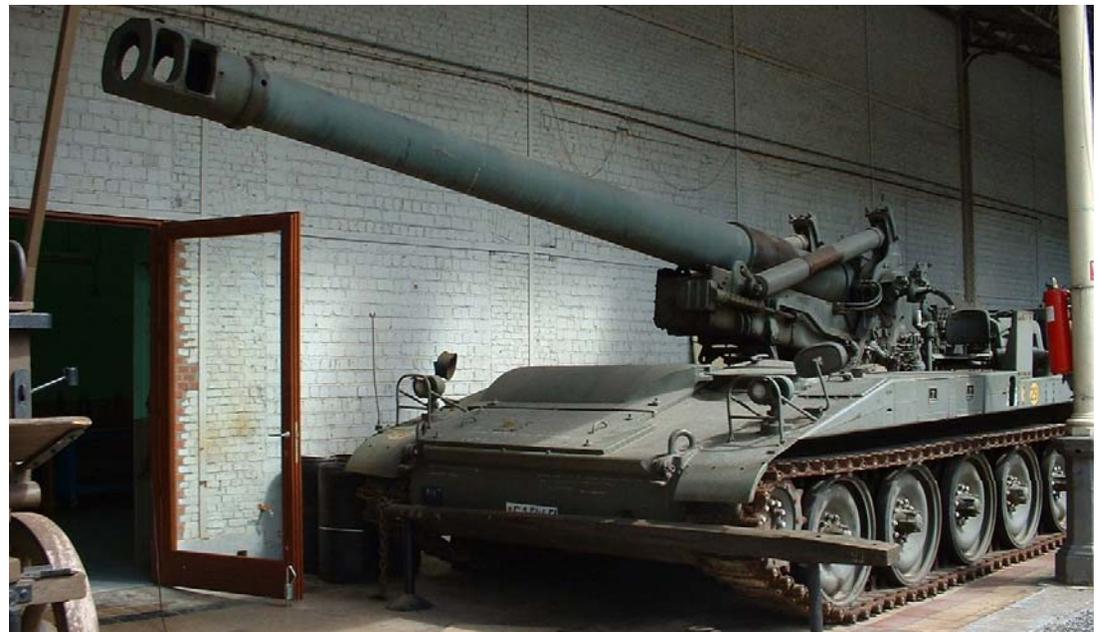
- In the mid-1970s, immediately following the Vietnam War, the US developed a requirement for an improved 8" cannon that would incorporate the lesson's learned from the 175 MM cannon to create a longer range, more accurate, heavy artillery system.
 - This system upgrade resulted in the M201A1 Cannon (M110A2 Howitzer)
 - an upgraded steel formulation and processing in the cannon
 - a higher impulse longer range charge and projectile system
 - a muzzle brake to maintain the impulse level delivered to the carriage
- In the 1980s, this system became the core of the cannon launched nuclear projectile program.
- This system was in use by the US Army until 1994.
- It is still in use with 5 other armies
